Report:

Atlanta Regional Airport-Falcon Field (Atlanta, GA) Pavement Management Report

Applied Pavement Technology, Inc.
1908 South First Street, Suite 201
Champaign, Illinois 61820
www.appliedpavement.com

OCTOBER 2025

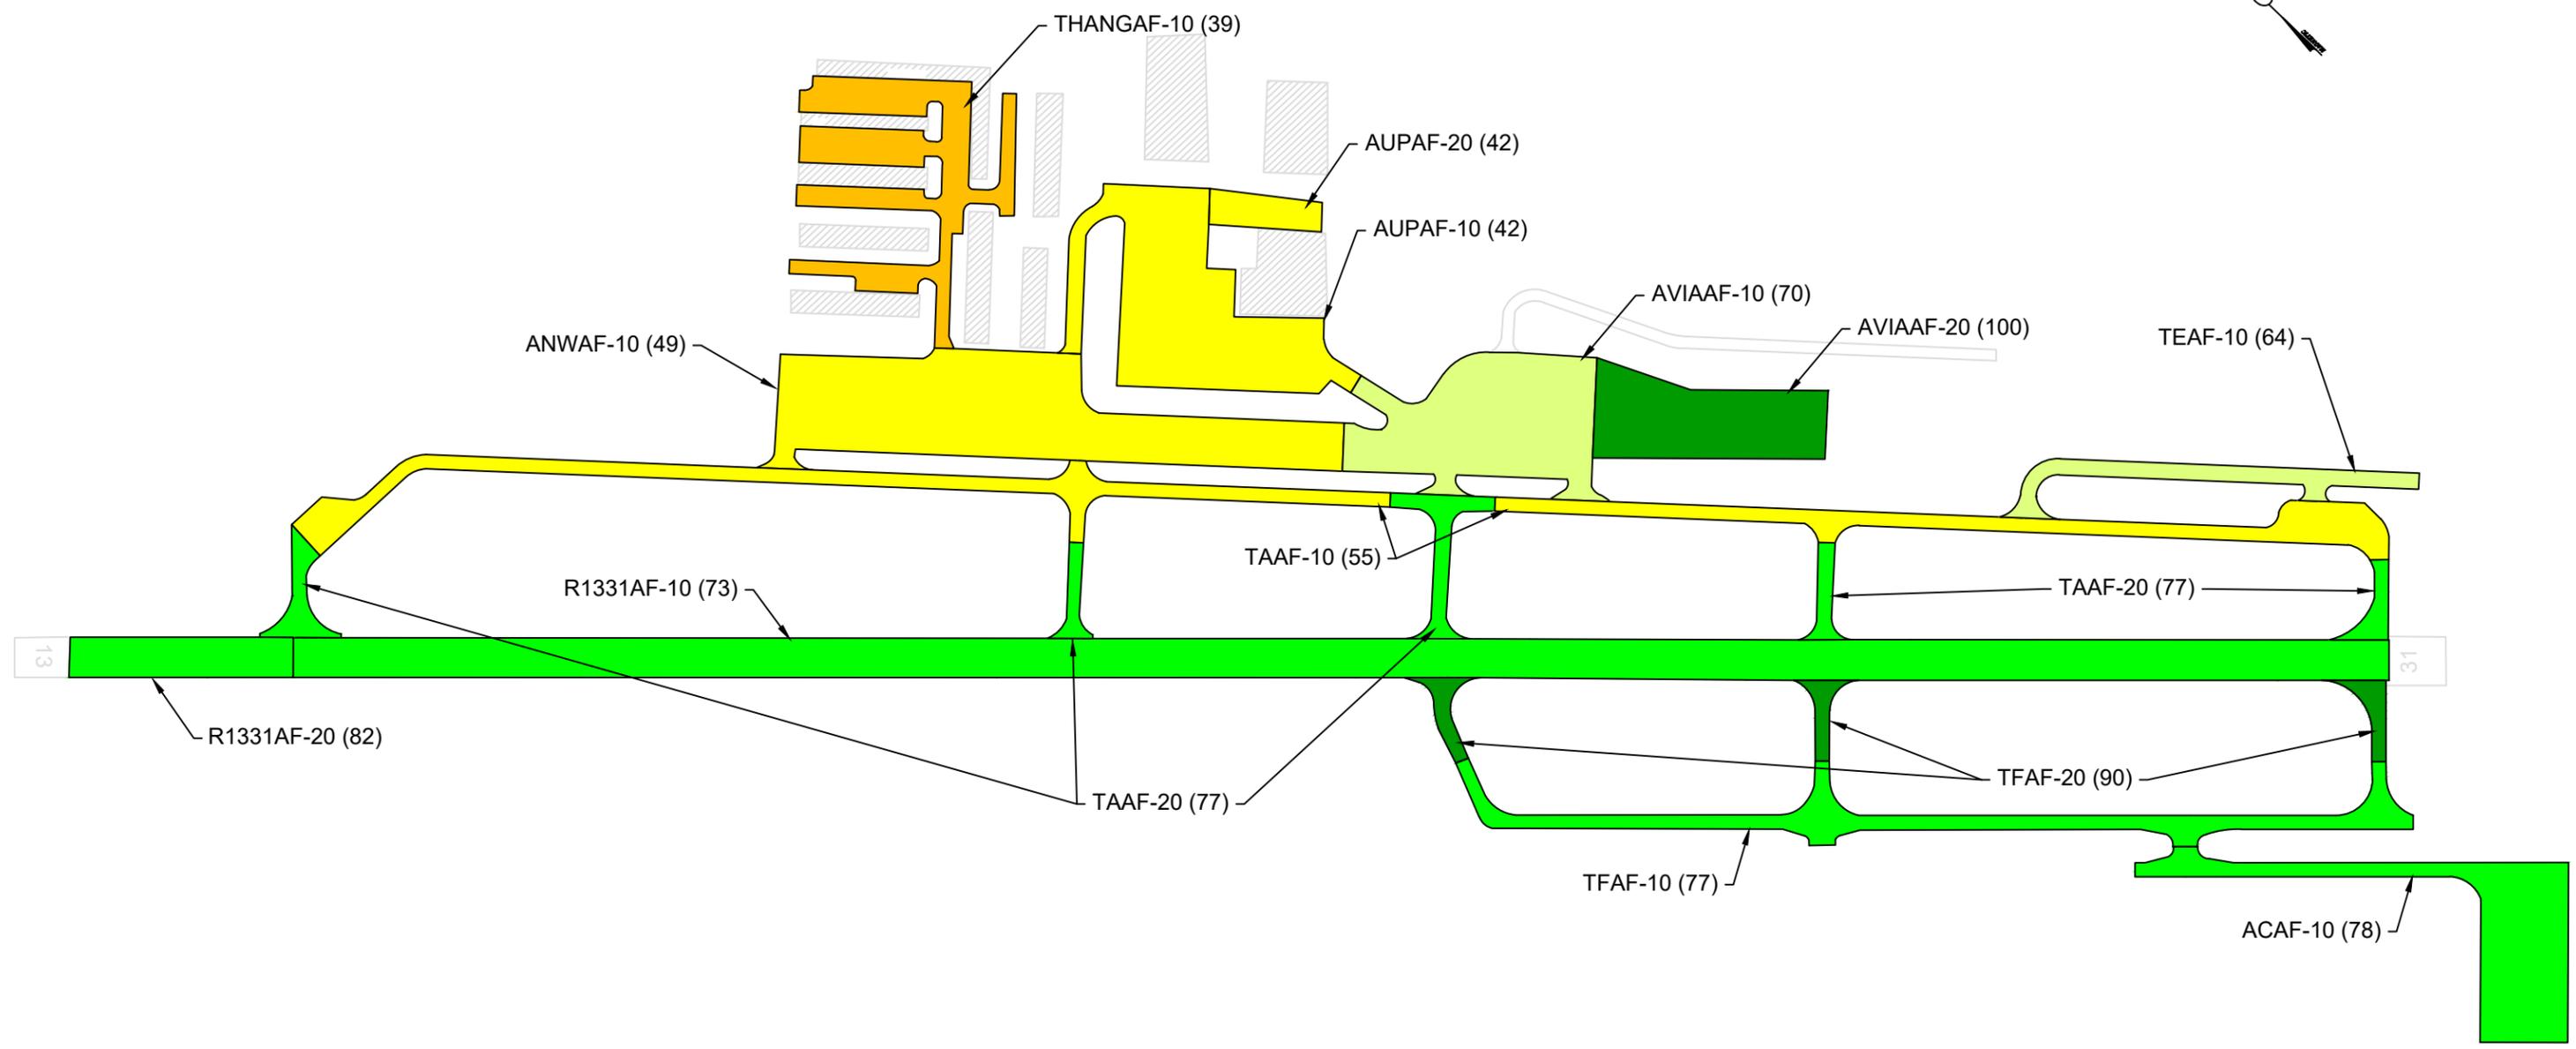
The 2024 area-weighted condition of Atlanta Regional Airport-Falcon Field is 65, with conditions ranging from 39 to 100 (on a scale of 0 [failed] to 100 [excellent]). This compares to a 2018 PCI of 67.

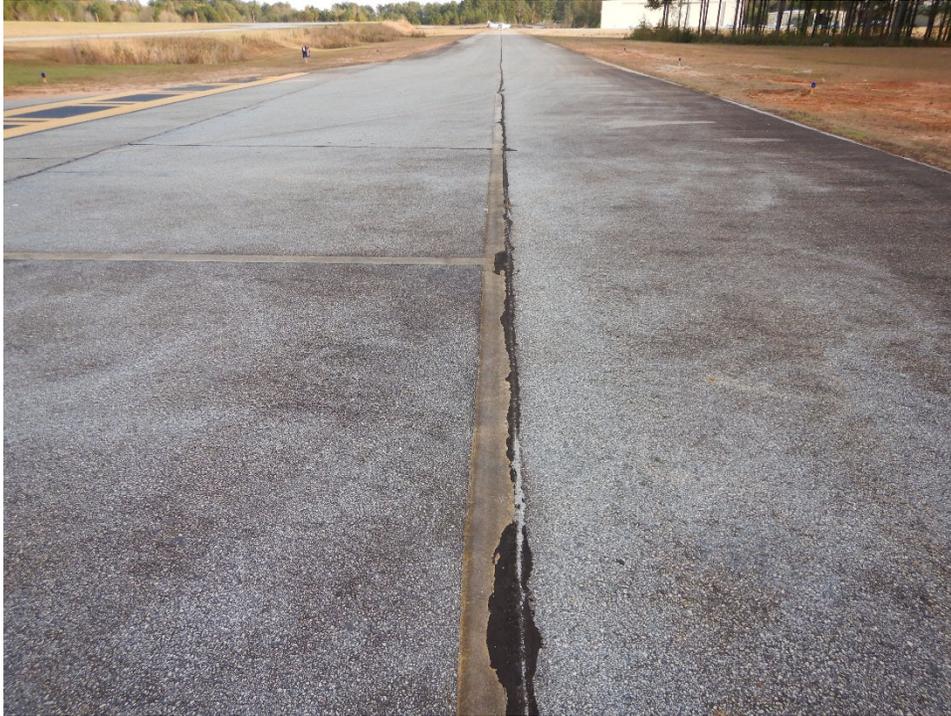
ACAF-10. L&T Cracking (Sample Unit No. 03).

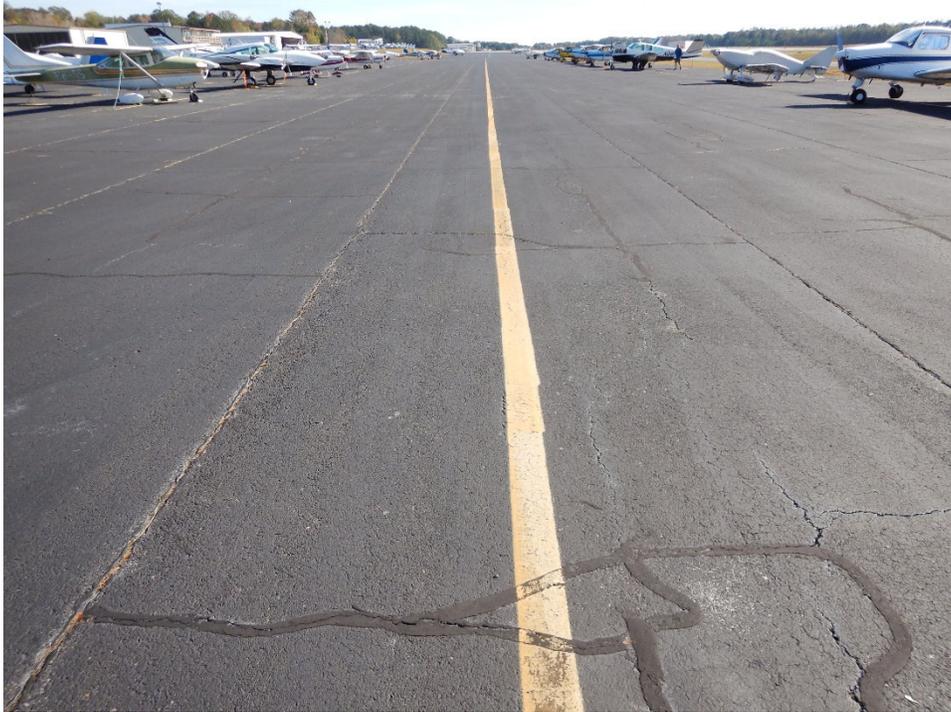
ANWAF-10. L&T Cracking (Sample Unit No. 40).

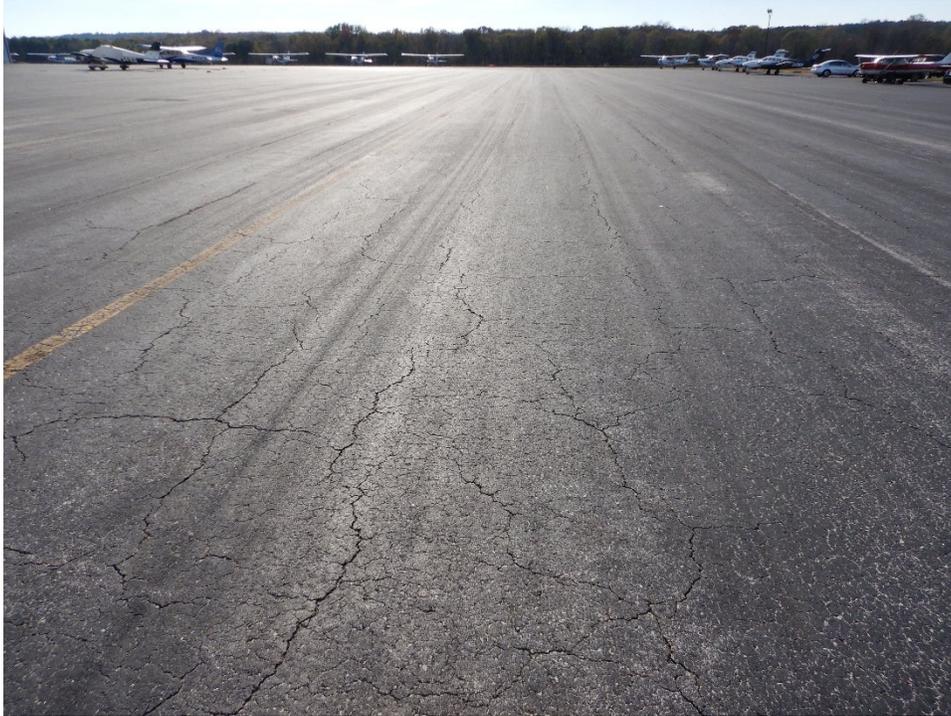
AUPAF-10. Block Cracking (Sample Unit No. 27).

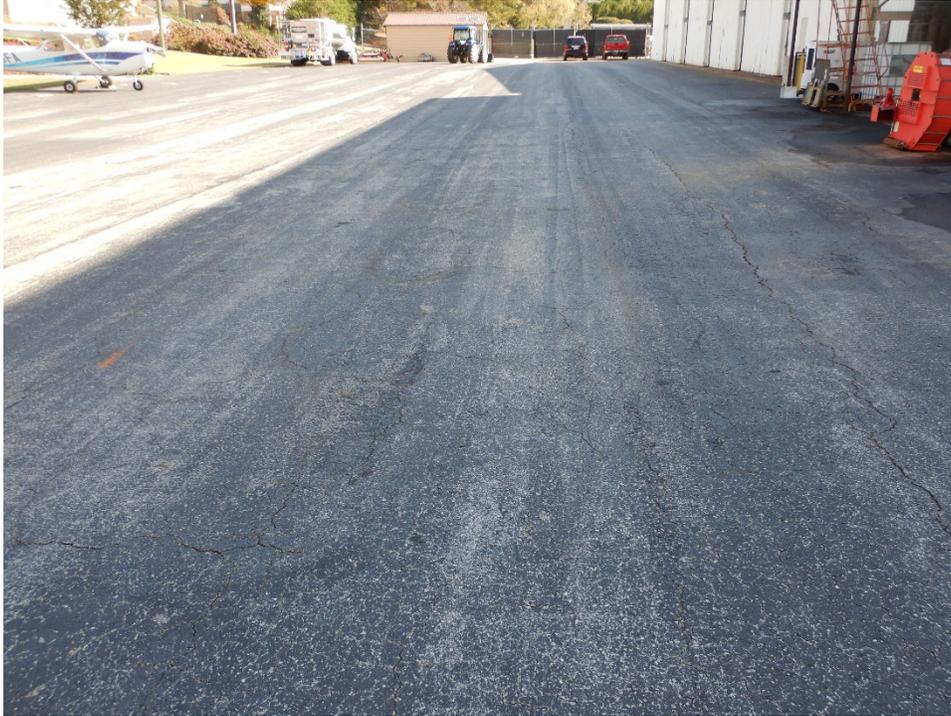
AUPAF-20. Block Cracking (Sample Unit No. 01).

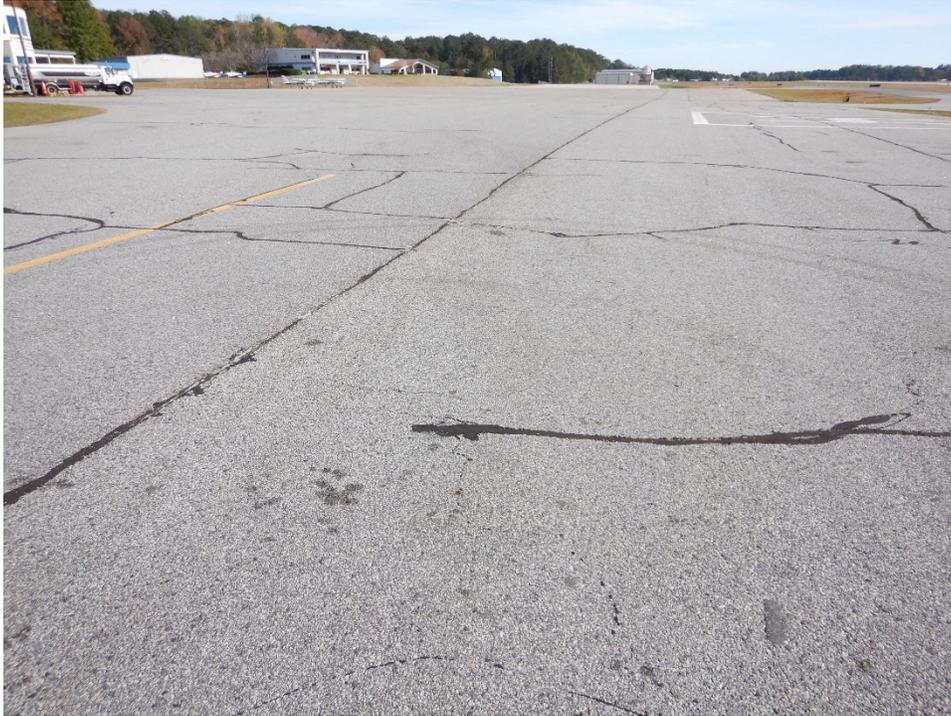
AVIAAF-10. L&T Cracking (Sample Unit No. 27).

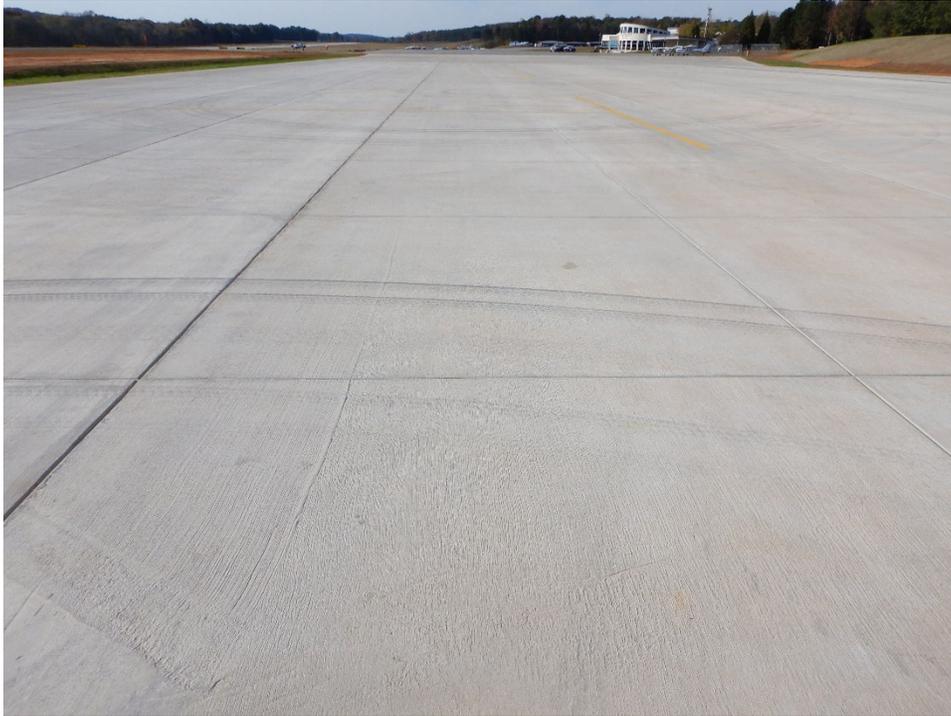
AVIAAF-20. Small Patching (Sample Unit No. 13).

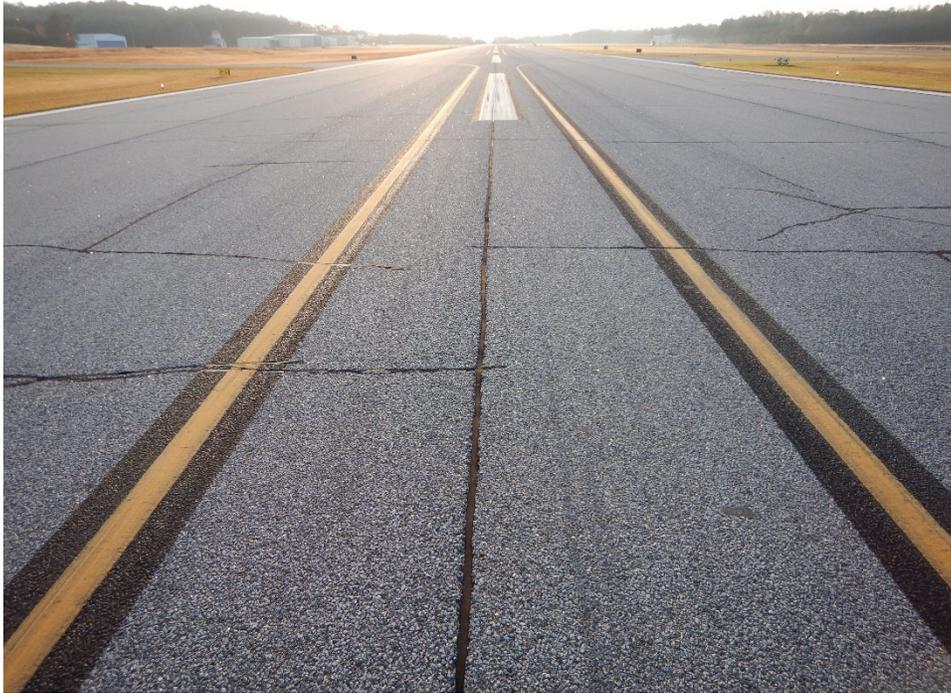
R1331AF-10. L&T Cracking (Sample Unit No. 87).

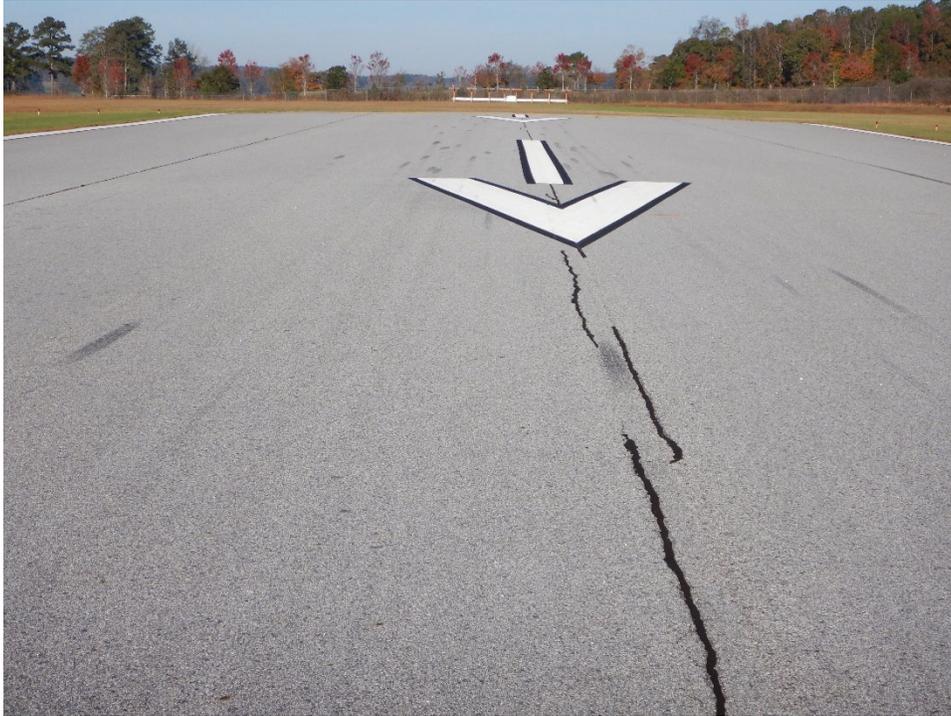
R1331AF-20. L&T Cracking (Sample Unit No. 10).

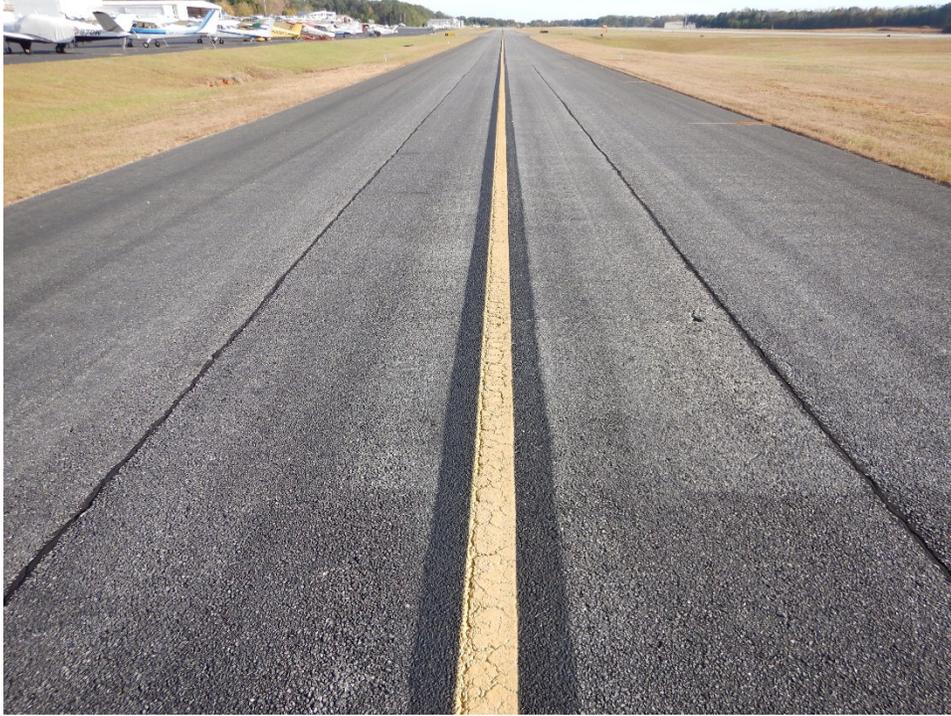
TAAF-10. Alligator Cracking (Sample Unit No. 04).

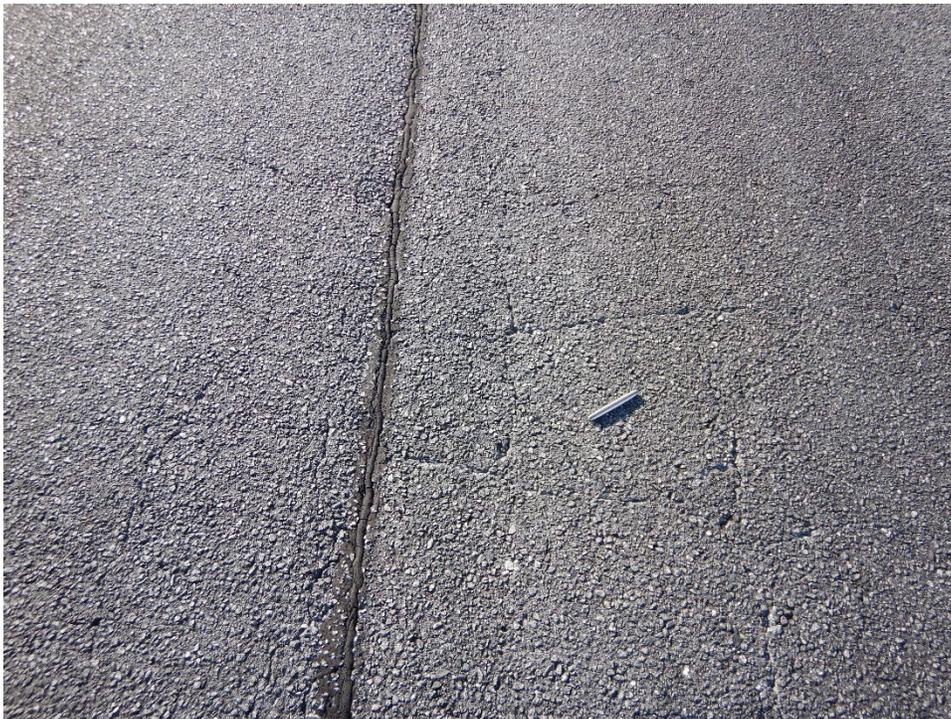
TAAF-10. L&T Cracking (Sample Unit No. 12).

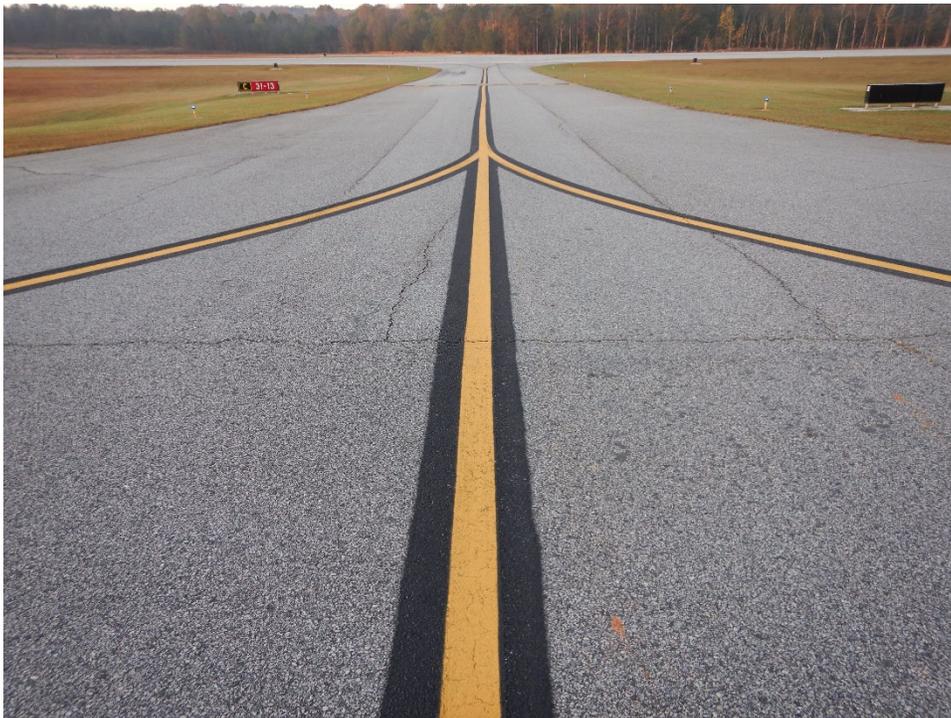
TAAF-20. L&T Cracking (Sample Unit No. 06).

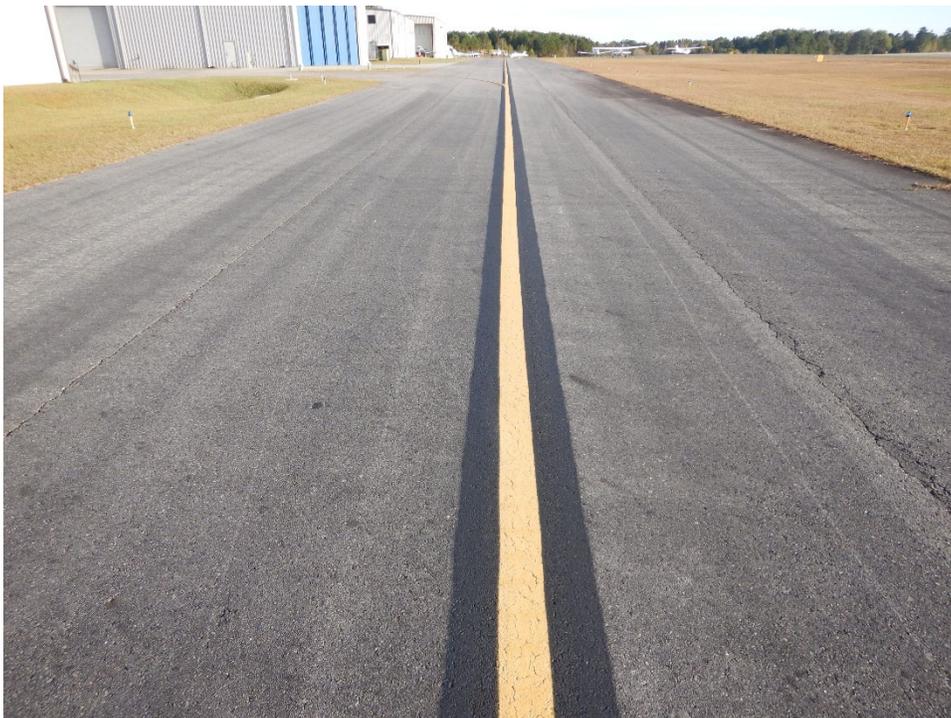
TEAF-10. L&T Cracking (Sample Unit No. 03).

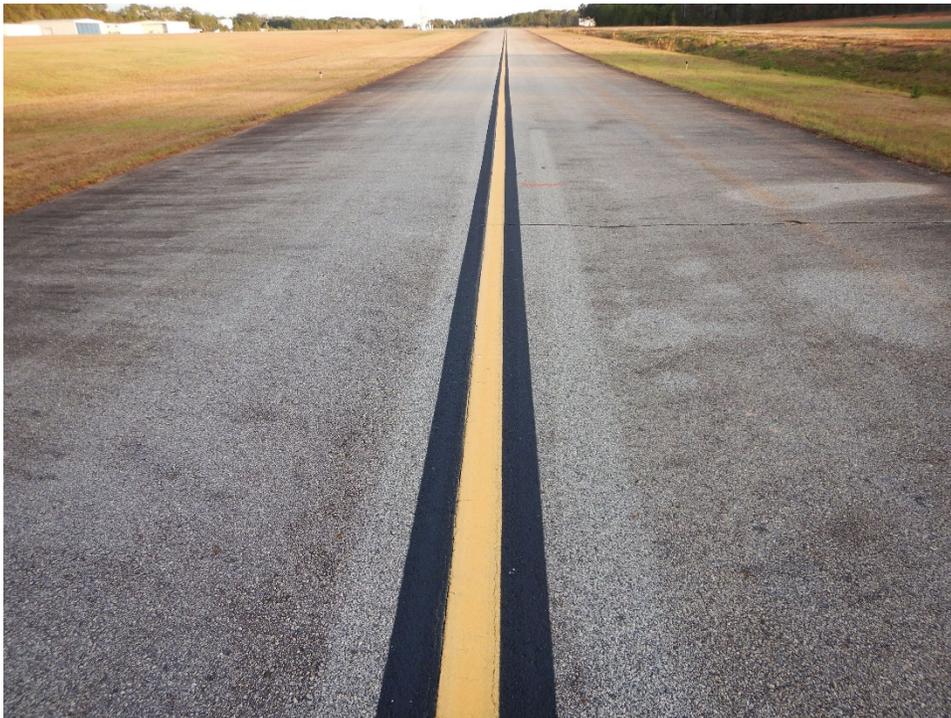
TFAF-10. Weathering (Sample Unit No. 05).

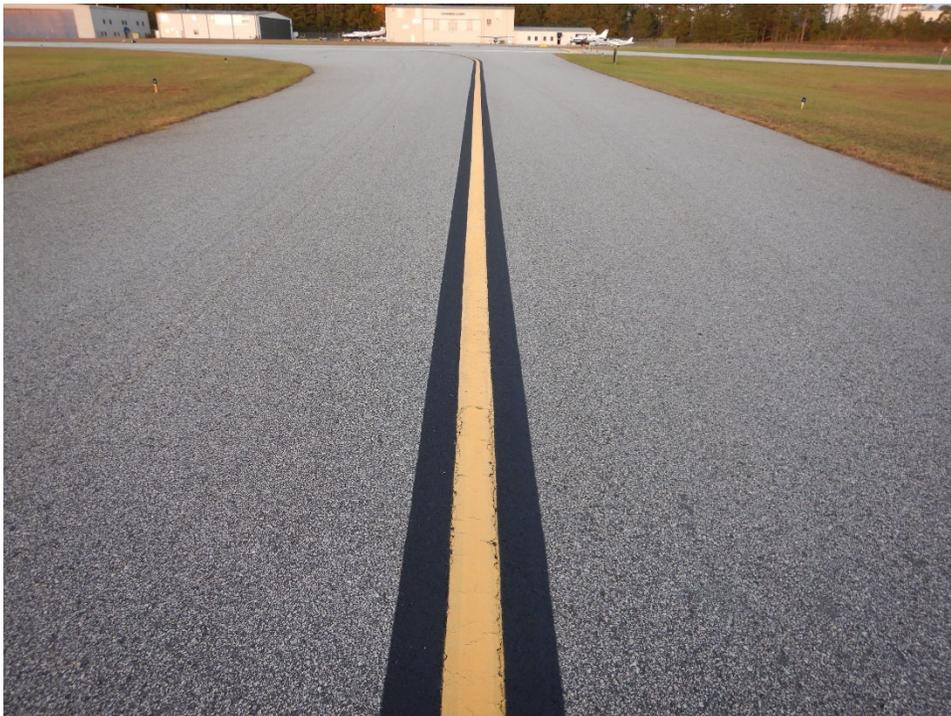
TFAF-20. Weathering (Sample Unit No. 06).

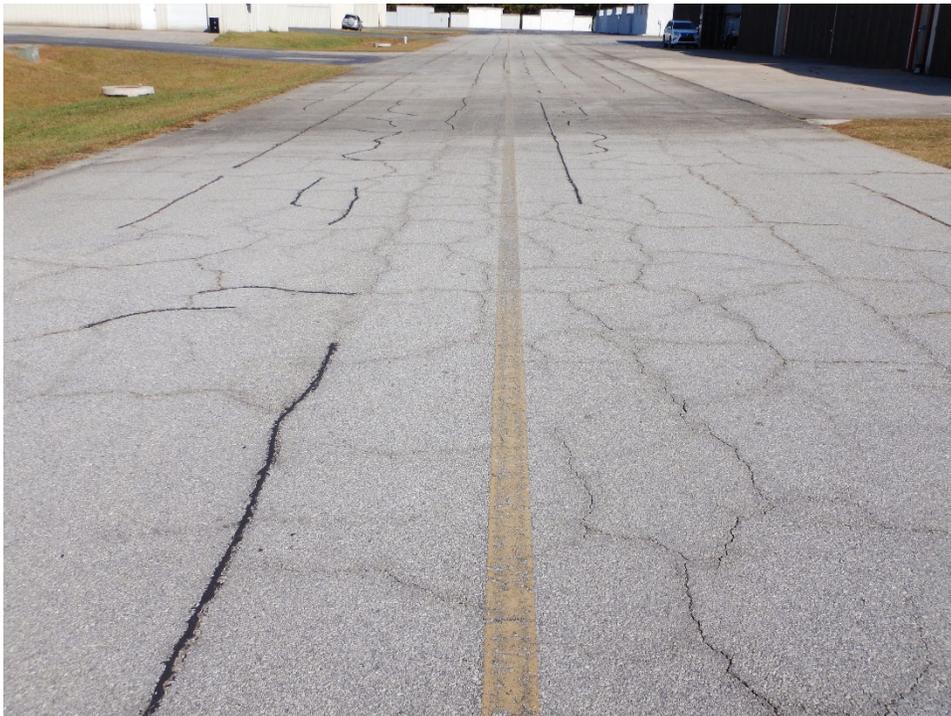
THANGAF-10. Block Cracking (Sample Unit No. 01).

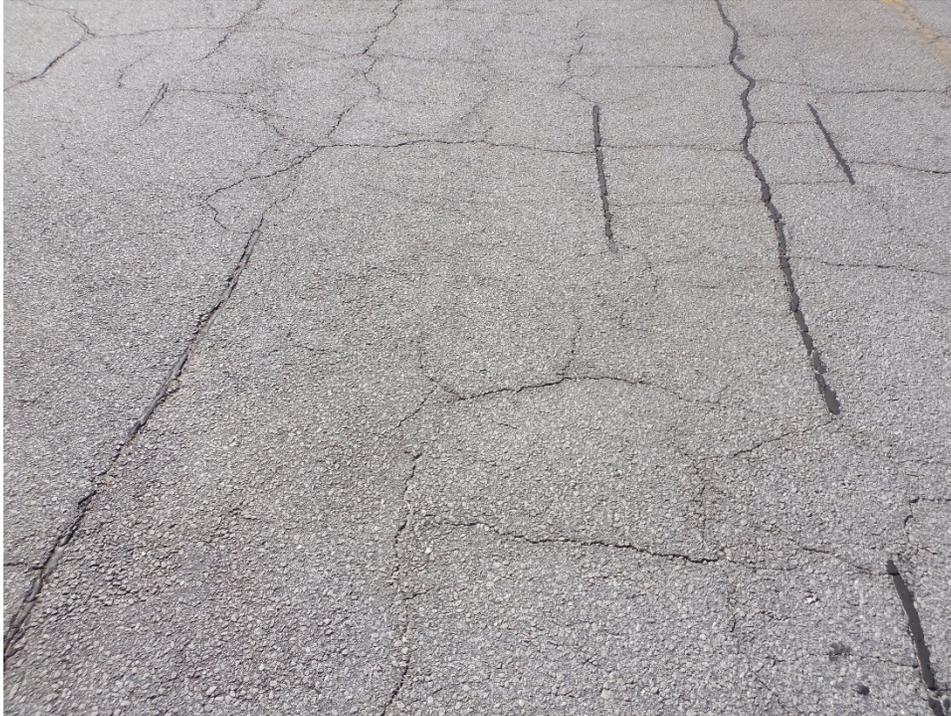
THANGAF-10. Weathering (Sample Unit No. 01).
