Report:

Atlanta Regional Airport-Falcon Field (Atlanta, GA) Pavement Management Report

Applied Pavement Technology, Inc.
1908 South First Street, Suite 201
Champaign, Illinois 61820
www.appliedpavement.com

OCTOBER 2025

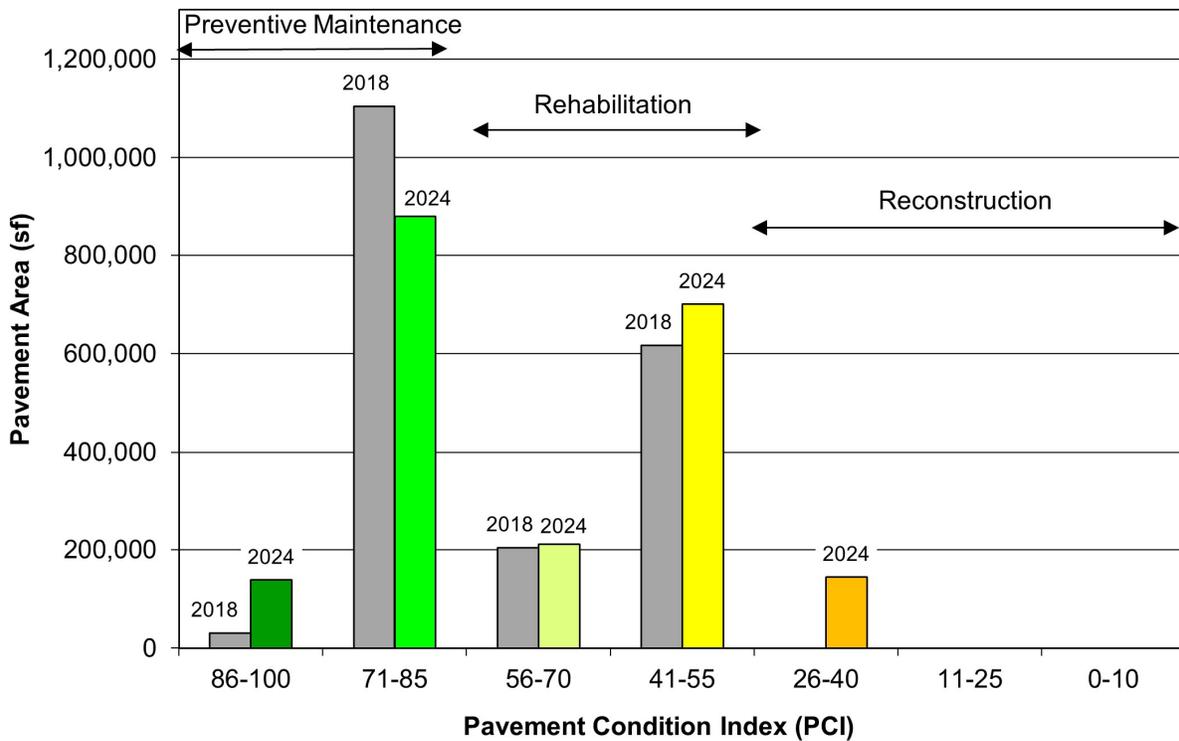
Figure 6. Condition distribution.

The 2024 area-weighted condition of Atlanta Regional Airport-Falcon Field is 65, with conditions ranging from 39 to 100 (on a scale of 0 [failed] to 100 [excellent]). This compares to a 2018 PCI of 67.
